115-20-10590**CORRECTION****Water body name:****Survey date:** 3/20/2015**Water body number:** 115-20-10590**Species & Lifestage:** Ps**Watershed:** Berners Bay-Frontal Lynn Canal**MTR:** C037S064E **Quad:** Juneau C-3

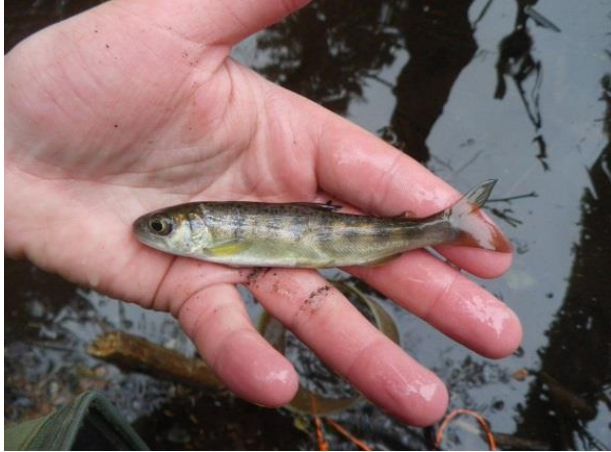
Findings: I surveyed this cataloged stream using minnow traps unit and a GPS. I caught juvenile coho salmon. There are several places where ATV's have crossed stream and created trails on both sides of stream. There is evidence that beavers were once active on this stream, but looks like they have moved on.

Figure 1.—Captured smolty rearing coho salmon.

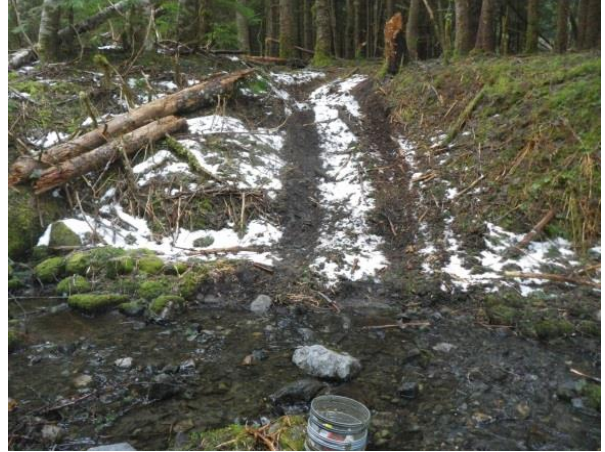
Figure 2.—One of several ATV crossings.

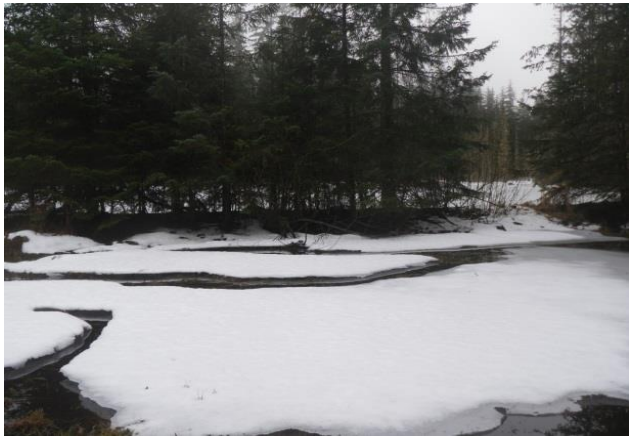
Figure 3.—Old beaver berm.

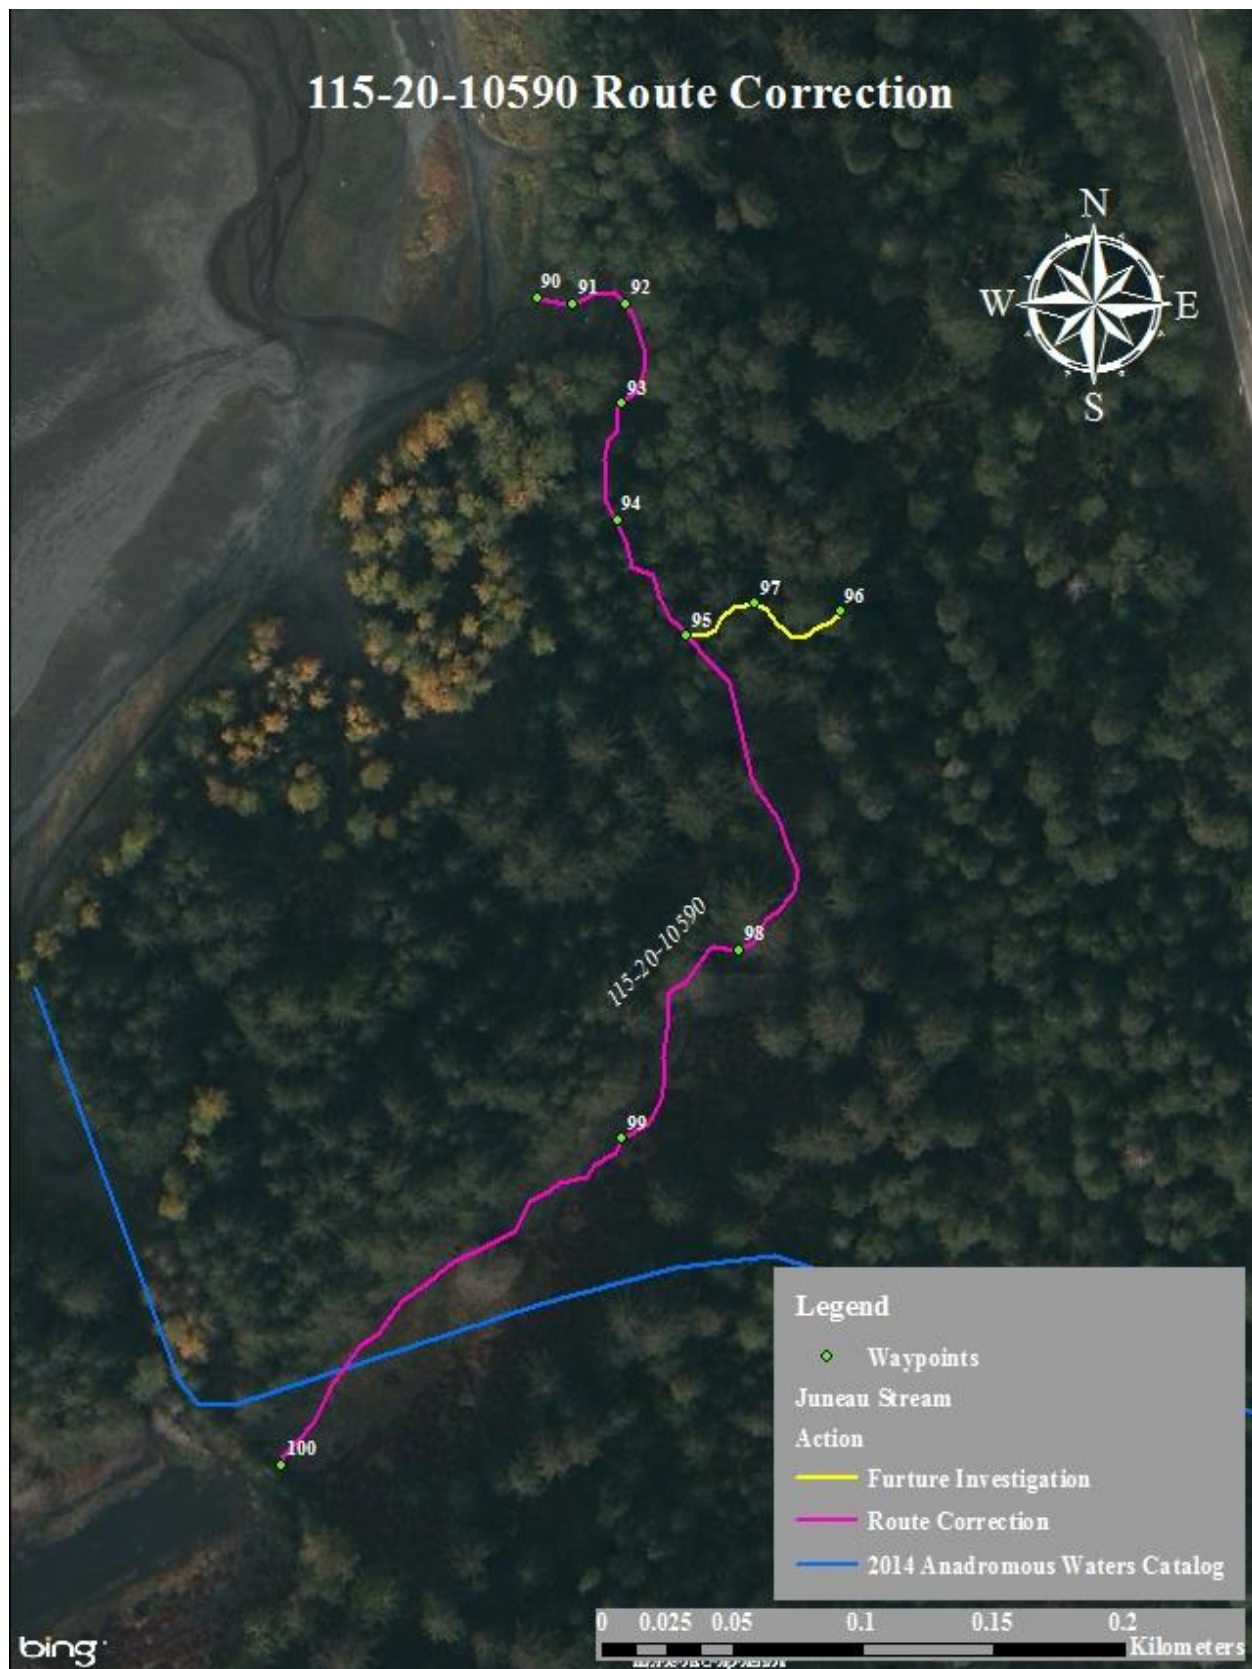
Figure 4.-115-20-10590 route correction map.

Recommendations: Correct the current route in the Anadromous Waters Catalog and include rearing coho salmon.
